NONDESTRUCTIVE ANALYSIS AND DEVELOPMENT

FINAL REPORT

Prepared for the
National Aeronautics and Space Administration
John F. Kennedy Space Center
Under Grant # NAG 10-0058

August 1993

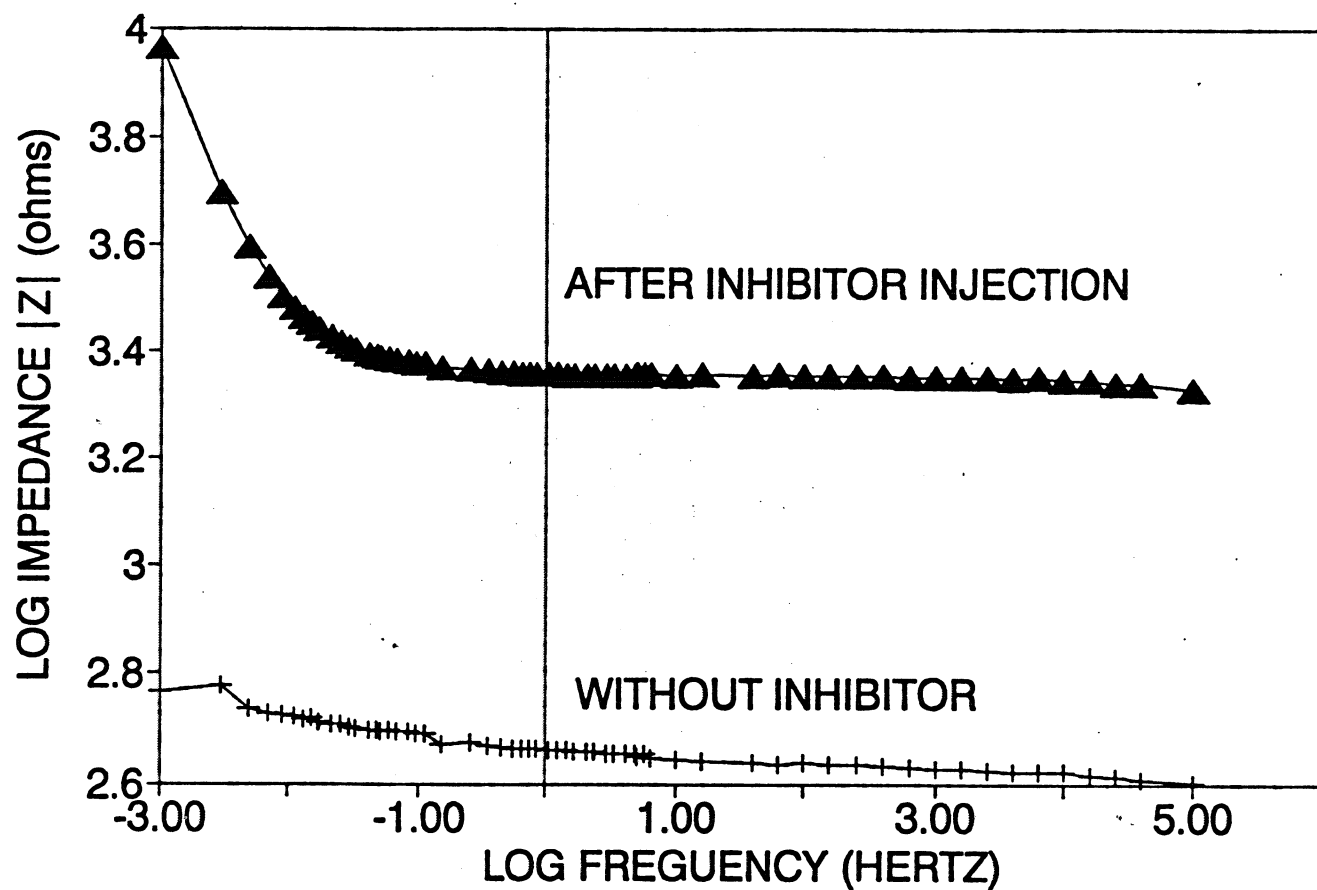
Figure 7 Bode plots showing that the higher value of R_p for concrete specimens containing 20 lb/yd³ NaCl with electrical injected inhibitor (tetrabutylammonium nitrite)

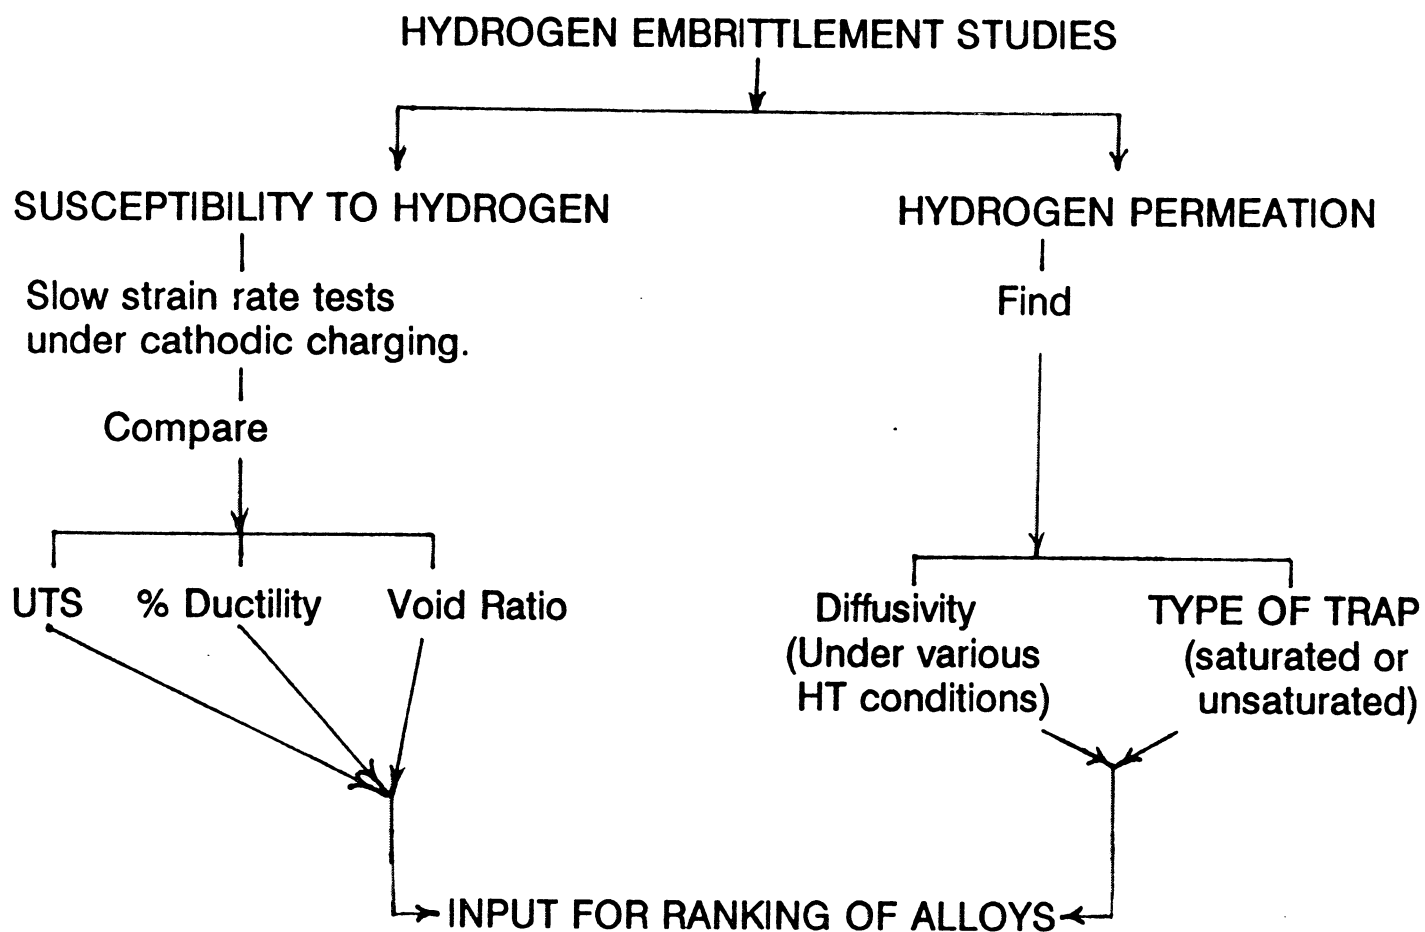
Figure 8 The Scheme For Ranking Of Different Alloys With Respect To Their Hydrogen Embrittlement

All alloys were susceptible to hydrogen. the first three were only slightly susceptible. Alloys 4 through 9 are moderately susceptible and alloys 10 through 14 are highly susceptible. C-22 showed absence of saturable irreversible traps which is good for hydrogen applications.

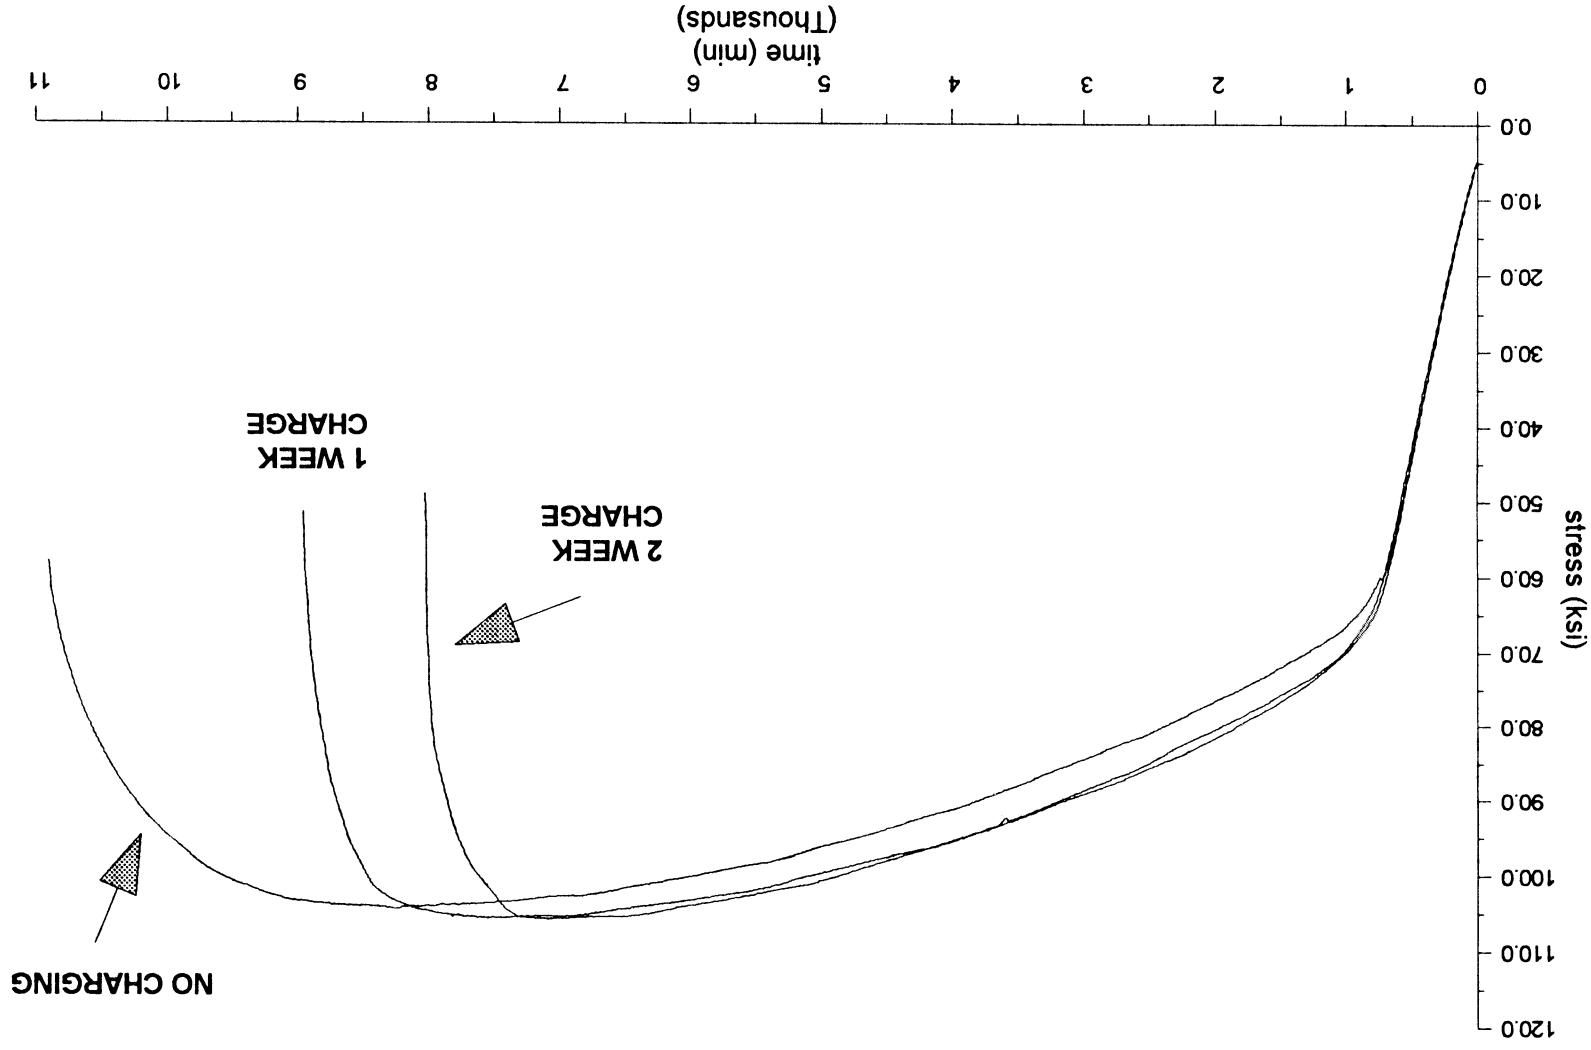
Figure 9 The stress-time behavior comparison for annealed Hastelloy C-22 with and without H charging under slow strain rate pulling.

Figure 9 shows the effect H has on the degradation of mechanical properties of Hastelloy C-22. Table III lists Diffusion Coefficients determined for some of the alloys. Each Diffusivity number is an average of three to four independent experiments. The determination of the activation energy indicated in the table makes it possible to find diffusivity of H at any temperature of interest. Table IV summarizes the degradation in various mechanical properties of Hastelloy C-22 due to H exposure. Finally Figure 10 shows the fractographic evaluation procedure and results obtained for two alloys. Such evaluation was performed for all alloys.
